# **Photo Rectification Plays an Important Role for Determining Fault in a Two Vehicle Crash**

By Lee DeChant  
DeChant Consulting Services – DCS Inc

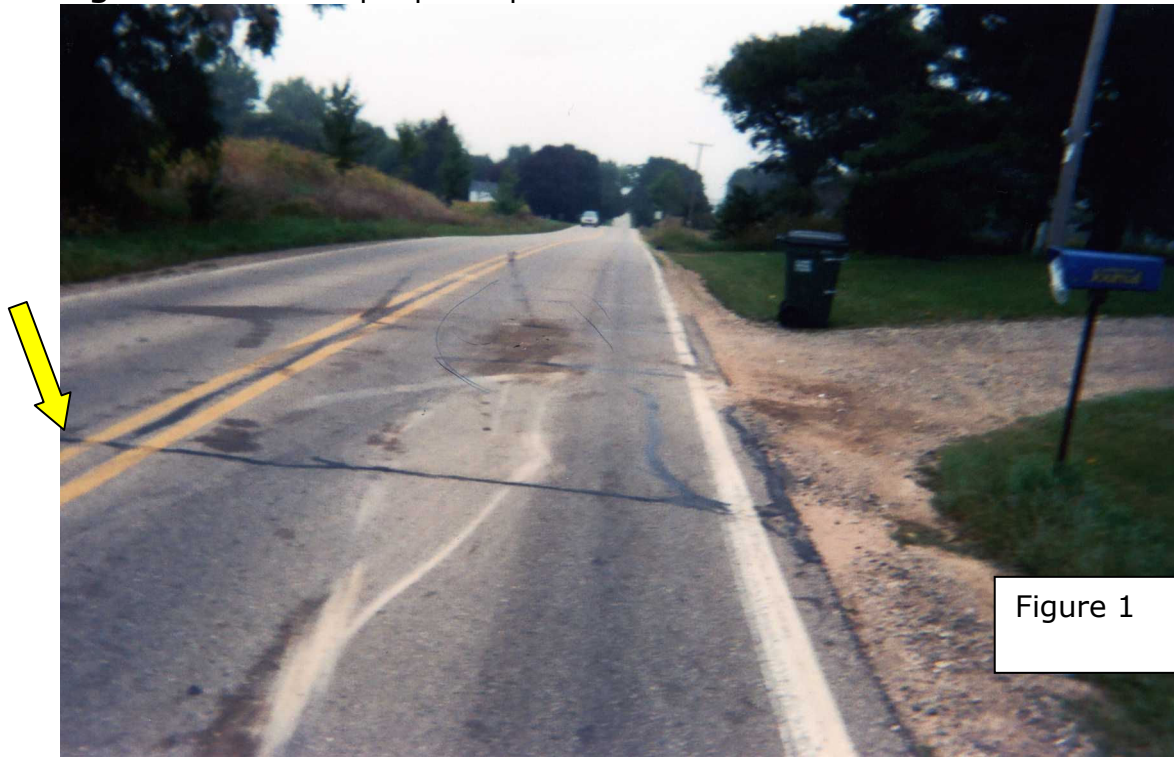
Figure 1

**Figure 1** is the oblique police photo with Vehicle 1 “cross over” tire mark

An experienced reconstruction practitioner reviewed one of the scanned police acquired scene photographs – analyzed months after the incident. The reconstruction practitioner determined that the police photograph revealed faint tire markings of the Vehicle 1 driver’s side tire (a yaw-mark) crossing-over into the southbound lane. Visually, from the photograph, the tire mark of Vehicle 1 appeared to be less than one-foot into the opposing lane in relationship to the solid double yellow centerlines. If that were the case, the driver of Vehicle 2 could have just stayed “on course” (southbound), or swerved just slightly to their right, in the southbound lane and the two vehicles would not have contacted each other.

The scanned photograph displaying the faint tire marking of Vehicle 1 and Point Of Impact, was actually ‘marked-up’ by someone with a ball-point pen
