Measuring Crash Scenes long after the event with iWitness™

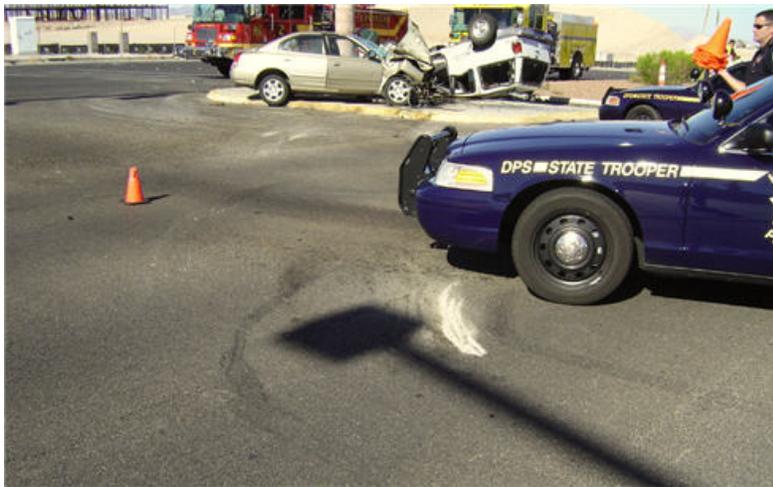
Fortuitously, four of the images recorded by the M.A.I.T trooper at the time the crash scene were well suited to photogrammetric measurement, even though this occurred months after the accident. This was ascertained during a training session for the *iWitness* photogrammetric system, which was being conducted by DeChant Consulting Services – DCS Inc. It was apparent that one image could be rectified to provide a full 2D representation of the AOI, while the other three images from the Trooper’s Sony camera could be used to measure the final 3D vehicle rest positions with respect to a traffic island at the street intersection of Sahara and Highway 215.

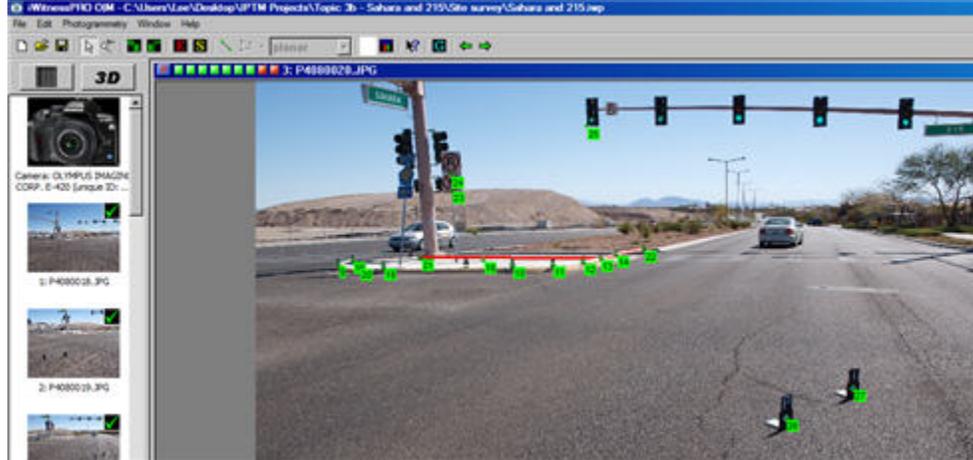
Ten images were employed from the post-event site visit to compute the Control Point positions that were then used in the *XYRectify* software to provide a plane rectification of one of the original images. This allowed the 2D coordinates of AOI tire mark and gouge locations to be determined with respect to

the street intersection and traffic island for both vehicles. The rectified image was scaled and imported into a CAD program.
